CHARACTERIZATION OF DEPOSIT LAYERS FORMED ON GREY CAST IRON

This paper presents the results of diagnostic examinations conducted on the water pipe made of grey cast iron that were operated in conditions for 260 thousand hours. The tube was exposed in a soil. The phase composition of the deposit layers formed on both sides of the tube walls (outside and inside) was examined using optical and confocal microscopy and X-ray diffraction. The obtained XRD test results showed that mainly α -FeOOH and γ -FeOOH is formed on the inside of the pipe wall. In turn, on the outside, in addition to the above-mentioned compounds, also SiO_2 is formed. The results of these examinations have shown a higher degradation of pipe on the outer side. The arithmetic mean deviation of the profile from the mean line was $6.23 \mu\text{m}$ and $8.07 \mu\text{m}$ for the inner and outer side of the pipe wall, respectively. The work demonstrates the usefulness of material science, especially X-ray structure, topography and surface studies, in characterizing the degradation processes of layers formed on grey cast iron exploited in the water supply industry.

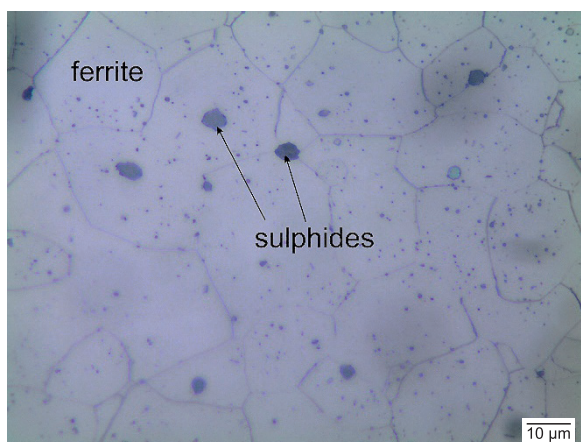
Results and Discussion

Fig. 1. Structure directly from the side of the pipe wall, magnification 1000×

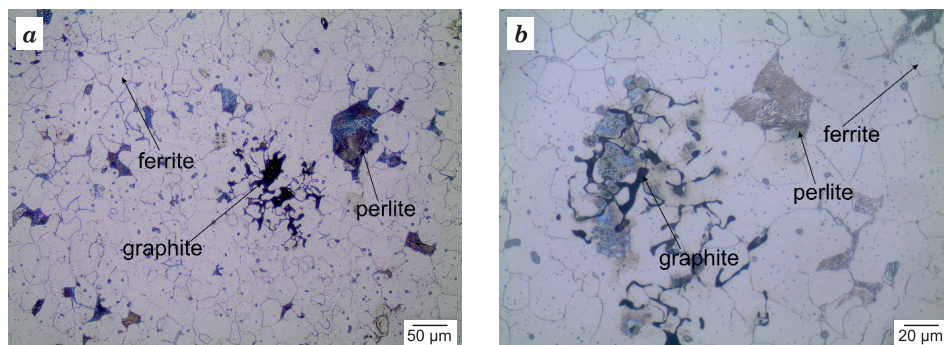
and numerous precipitations of sulphides (Fig. 2). Graphite precipitates occur in a branched form, characteristic of distorted graphite. This graphite is in the form of curved streaks that are branched in different directions. These strands touch each other at different points. In grey cast iron, excess carbon beyond the solubility limit in the austenite phase precipitates as flake graphite (SHANKAR et al. 2020). Sulfur in cast iron occurs in the form of iron and manganese sulphides ($FeMn$)S (STEFAN et al. 2021).

Fig. 2. Structure at the center of the pipe wall section. Visible ferrite, perlite, graphite and sulfides: *a* – magnification 200 \times , *b* – magnification 500 \times

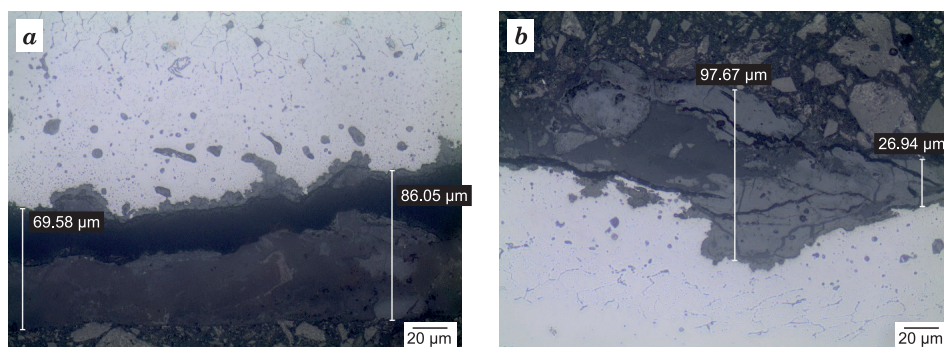
The microscopic observations carried out on the transverse sections showed the presence of deposits on both sides of the pipe wall (Fig. 3). The thickness of the layer on both sides was varied. At its widest point, the

Fig. 3. Cross-section of the sediment layer:
a – inner side of the pipe wall, *b* – outer side of the pipe wall

layer had a thickness of 86.05 μm and 97.67 μm for the inner and outer sides of the pipe wall, respectively. In both cases, pitting corrosion is locally visible at the contact of the sediment layer with the substrate. On the inside, a gap was observed between the native material and the layer. On the other hand, observations of the outer side revealed numerous cracks in the sediment layer. These cracks take on a multidirectional character. In the paper (YANG et al. 2012), sections of cast iron pipes after 20-25 years of operation were examined. The researchers found mounds, so-called corrosion nodules, and thick continuous scales on the highly internally corroded pipe surfaces. WICHOWSKI et al. (2021) did not observe pitting corrosion in cast iron pipes after 30 years of operation. In addition, no reduction in wall thickness and wall degradation were observed, which indicates a slight damage to the pipes and a possible extension of their service life. Researchers have shown (WICHOWSKI et al. 2021) that the structure and chemical composition of the accumulated sediments are different in both layers: the outer and inner layers. The chemical composition of the accumulated

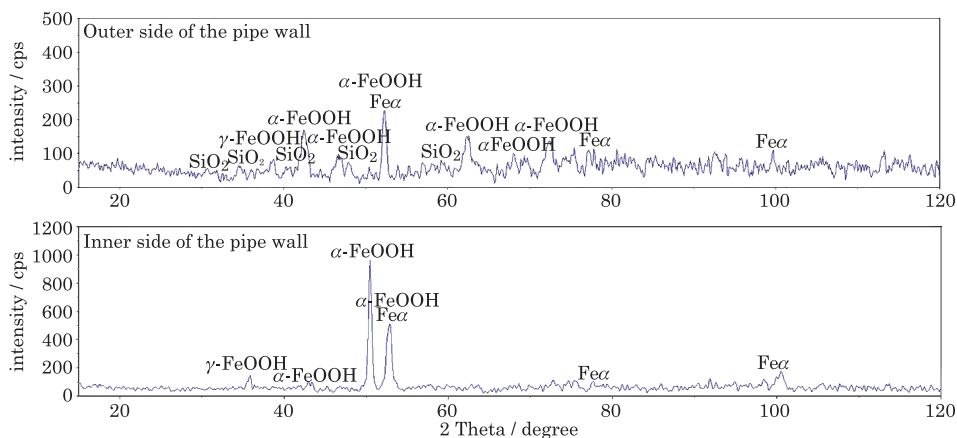
The obtained XRD test results showed that mainly goethite (α -FeOOH) with a small amount of lepidocrocite (γ -FeOOH) is formed on the inside of the pipe wall. In turn, on the outside, in addition to the above-mentioned compounds, also quartz (SiO_2) is formed. The results of studies by YANG et al. (2012) showed that magnetite (Fe_3O_4) and α -FeOOH were the main components formed on the inside of the pipe wall. The presence of Goethite on cast iron pipes was also observed by WICHOWSKI et al. (2021). In addition to the above-mentioned deposits, researchers (YANG et al. 2012) also observed, although in smaller amounts, such as: lepidocrocite, siderite (FeCO_3), green rust ($\text{Fe}_6(\text{OH})_{12}\text{CO}_3$), hematite (Fe_2O_3), akaganeite (β -FeOOH), iron carbonate hydroxide hydrate ($\text{Fe}_6(\text{OH})_{12}\cdot\text{CO}_3\cdot 2\text{H}_2\text{O}$), honessite ($\text{Ni}_6\text{Fe}_{23}+(\text{SO}_4)(\text{OH})_{16}\cdot 4\text{H}_2\text{O}$) and pyrite (FeS_2). The presence of γ -FeOOH was also confirmed in (WICHOWSKI et al. 2021). On several of the dozens of samples, YANG et al. (2012) also revealed non-iron-based phases, such as: SiO_2 , calcite (CaCO_3), albite ($(\text{Na,Ca})\text{Al}(\text{Si,Al})_3\text{O}_8$), microcline ($\text{K}(\text{AlSi}_3)\text{O}_8$), gypsum ($\text{CaSO}_4\cdot 2\text{H}_2\text{O}$). The presence of CaCO_3 , Fe_3O_4 , α -FeOOH, SiO_2 was also confirmed in the paper (LI et al. 2018). Also detected: tenorite (CuO), manganese oxide (MnO), zincite (ZnO) and hydrozincite ($\text{Zn}_5(\text{CO}_3)_2(\text{OH})_6$). Short-term laboratory tests (6 months) (GUO et al. 2020) confirmed the formation of an effective anti-corrosion scale layer consisting of α -FeOOH and CaCO_3 .

Fig. 4. Diffraction pattern of the outer and inner side of the pipe

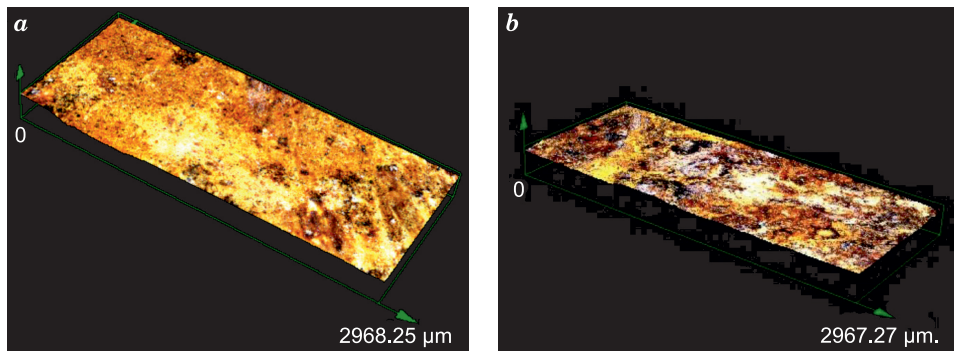
The obtained results of the surface topography showed that on the outer side of the pipe wall, the sediment layer has a more developed surface (Figs. 5, 6, Tab. 1). The arithmetic mean profile deviation from the mean line was less than two units higher for the outer side of the pipe wall. A similar growth character was

Fig. 5. 3D view, confocal microscope:
a – inner side of the pipe wall, *b* – outer side of the pipe wall

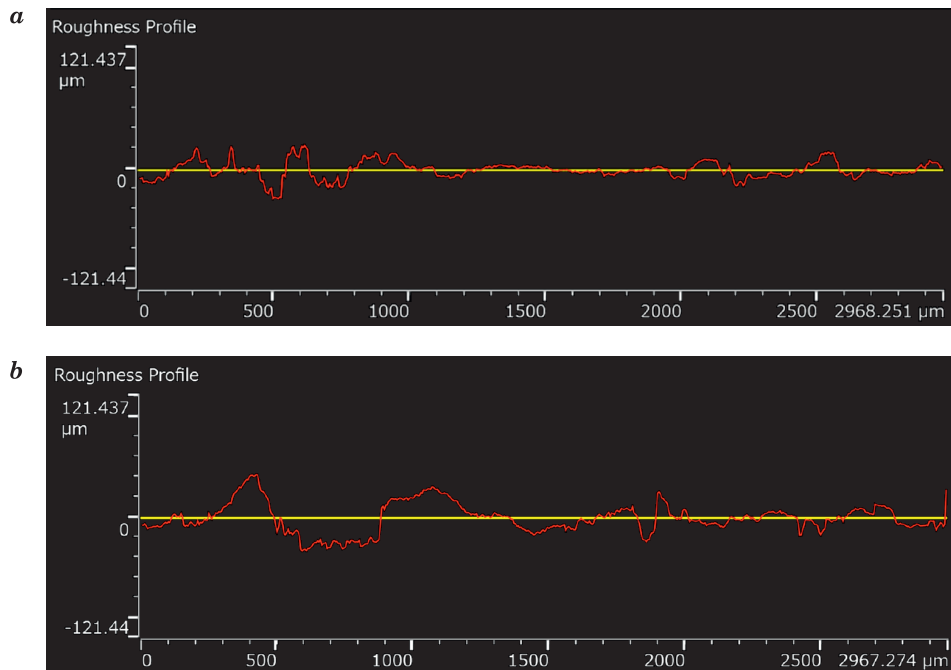
Fig. 6. Roughness profile: *a* – inner side of the pipe wall, *b* – outer side of the pipe wall

observed for the Rz parameter, only by 6.5 units. A slightly smaller increase was observed for the arithmetic mean of the waviness profile ordinates (an increase by 1.26 units). The greatest increase was related to the Wz parameter and amounted to as much as 13.96 μm . As shown in the literature, digital microscopes can be used for empirical roughness measurements of the formed sediments on water pipes (WICHOWSKI et al. 2021). Observations of the surface topography of water pipes are very important due to the progressive development of their corrosion. ASADI and MELCHERS (2018) presented the observations of the surface topography of cast iron pipes exposed for 34 to 129 years in clay soils. For this pipes, pitting was inferred to progress in a step-wise manner, with limited, staged increases in pit depth and lateral amalgamation of closely neighbouring pits to form plateaus from which new pitting occurs, in a manner generally similar to that reported for steels.
