INFLUENCE OF SELECTED ASPECTS OF THE TECHNICAL CONDITION OF MEANS OF TRANSPORT OPERATING IN WIELKOPOLSKA IN POLAND ON ROAD SAFETY

Piotr Gorzelanczyk

Stanislaw Staszic University of Applied Sciences in Pila

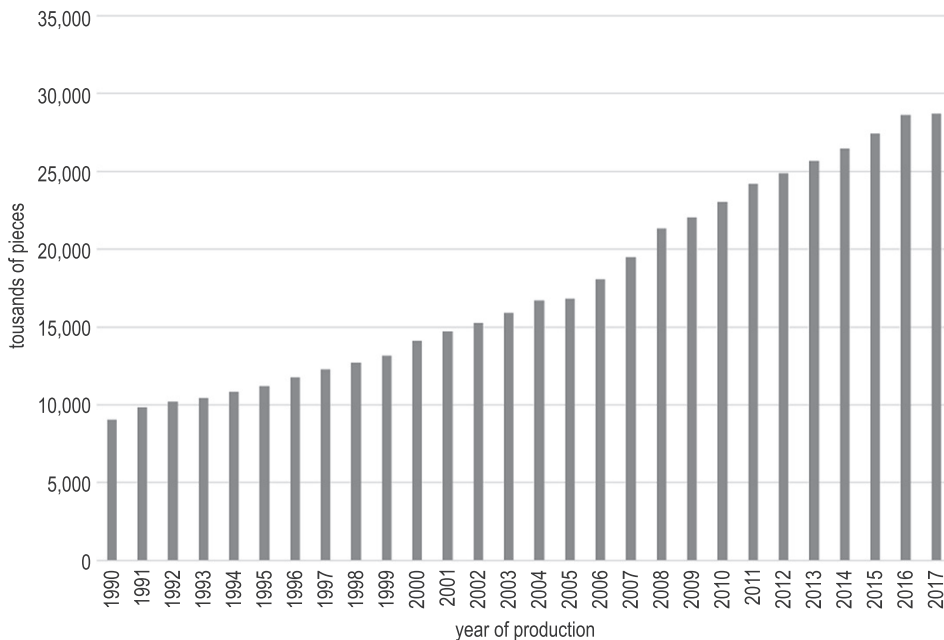
Fig. 1. The number of means of transport in 2001-2017

In recent years, there has been a rapid development of motorisation, and this has caused an increase in the number of vehicles on Polish roads (Fig. 1). In the last 10 years, the number of registered cars in Poland increased by nearly 50%.

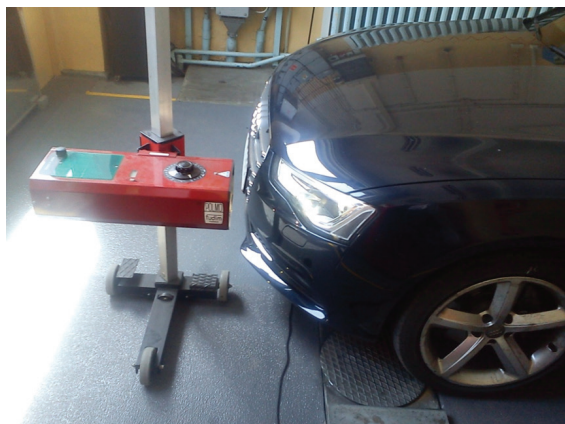
vehicle (Fig. 2). The device's knob is set in the upper position and the photoresistor is in the leftmost position, which simulates the view of the driver's eyes driving in the opposite direction. The value read from the display is considered to meet the requirements if it does not exceed 1 lux.

Fig. 2. Inspection of the technical condition of lighting

At the vehicle inspection station, the first measured quantity is the intensity of light, which determines whether the light emitted by the headlamps in the tested vehicle can dazzle drivers driving in the opposite direction to the tested

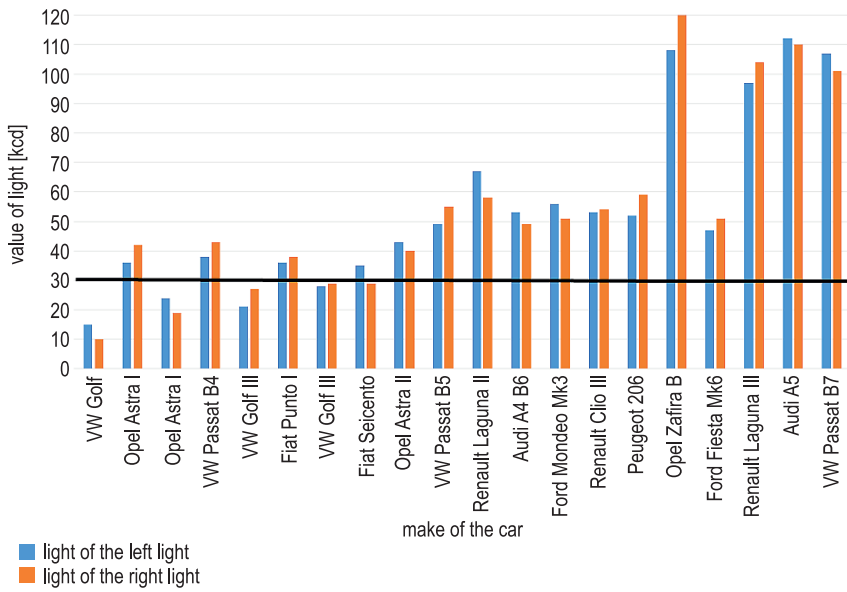
Fig. 5. Light of left and right light

The next parameter examined was the luminous intensity of the dipped beam. Pursuant to Polish law, the reflector must shine with a luminous intensity of at least 30 kcd, and the sum of all luminous intensity of the lights must not exceed 225 kcd.

It was found that not all vehicles meet the requirements for traffic lights. In the case of a minimum value of light in four vehicles, it was not reached by the left headlamps, and in five vehicles it was satisfactory. This applies mainly to vehicles manufactured in the early 1990s and earlier, and those in which older technologies were used, both light sources and its radius. In the case of the VW Golf II, the sum of the luminous intensity of all high-beam headlamps did not exceed even 30 kcd, which is why it is recommended to replace the headlamps in this vehicle. In the tested vehicles it was found to be good or very good.

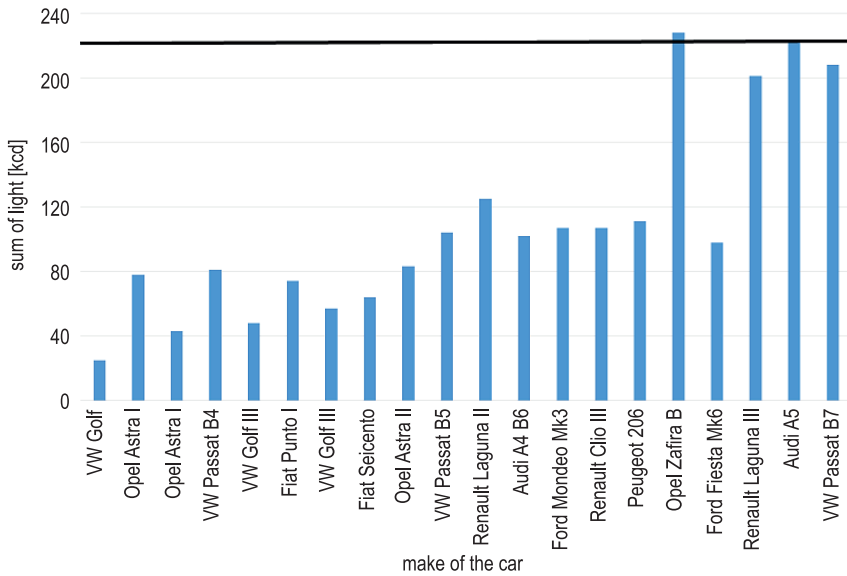
Fig. 6. Total light of lights

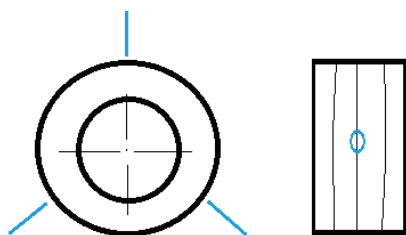
Fig. 7. Places where tread height measurements are made: blue lines characterize the place of measurement at 120°

Tread measurements were made in the middle of the tread width. These measurements were made three times for each tire with a 120° shift, which is schematically shown in Figure 7. This allowed measurements to be made at various locations around the circumference of the tires. In this way, it is possible to determine whether the tire has the required tread height or no local wear or wear that disqualifies it from continuing use.

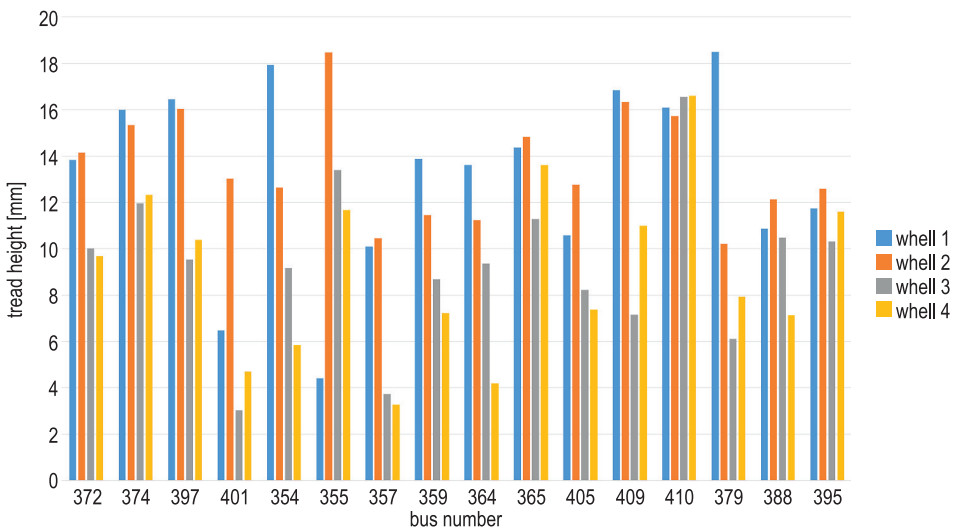
Fig. 9. Bus tread height MZK Pila

Table 5 and Figure 9 summarize the average tread height of the first, second, third and fourth wheel after the last measurement. The minimum permitted tread height on the buses in question should be 1.6 mm.

Due to the preservation of the actual image data for tire tread wear, buses that had tires replaced in a given wheel or wheels 3, 4 (due to the twin wheels) were excluded from the calculations (Tab. 7 and Fig. 9). These exclusions include buses and selected wheels with side numbers:

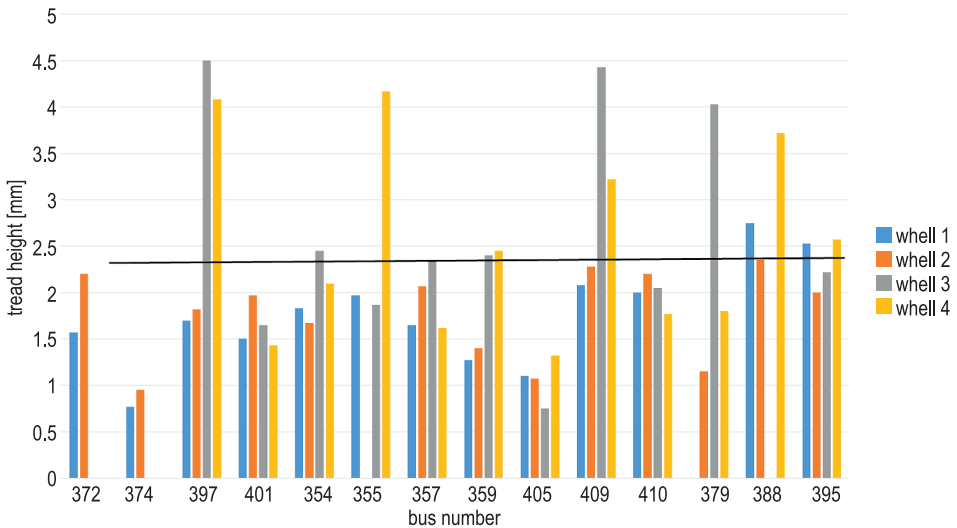
Fig. 10. Consumption of bus tires: minimum permissible tread depth

The research shows that the tires at the back of the buses wear one and a half times faster than the tires on the axles at the front of the vehicle. This is mainly due to frequent braking and acceleration, turning of the wheels during manoeuvring, bruising the sides with curbs and the implementation of courses with fully filled buses contributes to the intensification of tire wear. In addition, brushing against curbs causes a negative impact on the tire structure and shortens the service life, despite sufficient tread height.

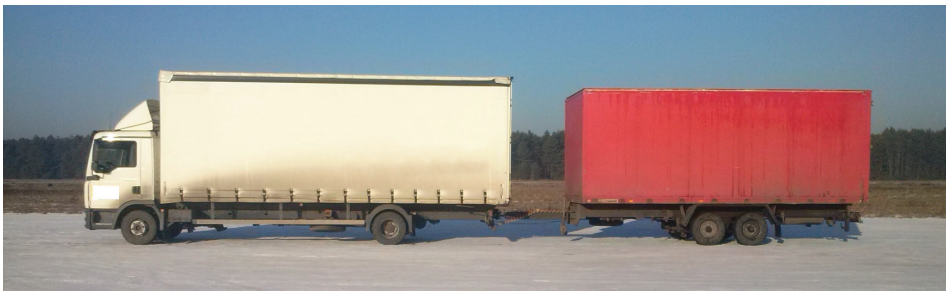
Fig. 11. MAN TGL 12.240 + trailer

MAN year of production 2009 – a vehicle used only for driving lessons. Trailer year of production 1996 – also used only for driving lessons. Both the car and the trailer were used unladen.

Tests on the condition of truck tires used for driving lessons consisted of measuring twenty-four tires at regular intervals, at the same points using an electronic calliper. The MAN TGL 12.240 + Trailer and MAN FH2000 + Trailer were used for the tests.

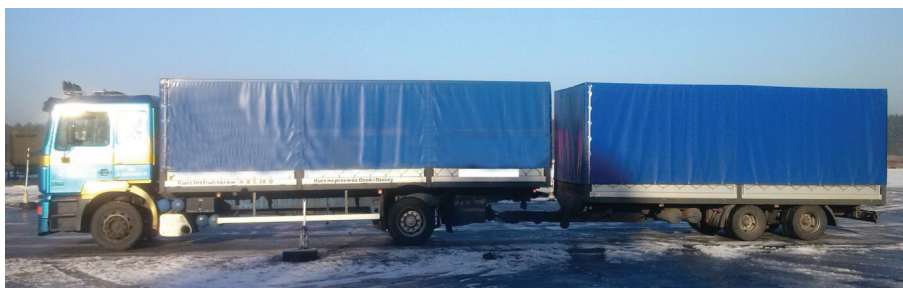
Fig. 12. MAN FH2000 + trailer

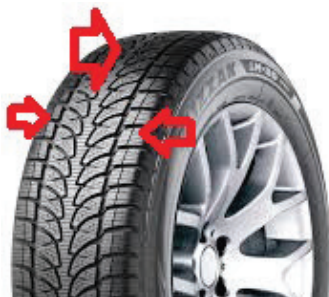
The tire tread height test was carried out at three points on the tire width, in the inner, middle and outer parts of the vehicle. The tests took place after every 40 hours of work of a given research object.

Fig. 13. Places of measurements

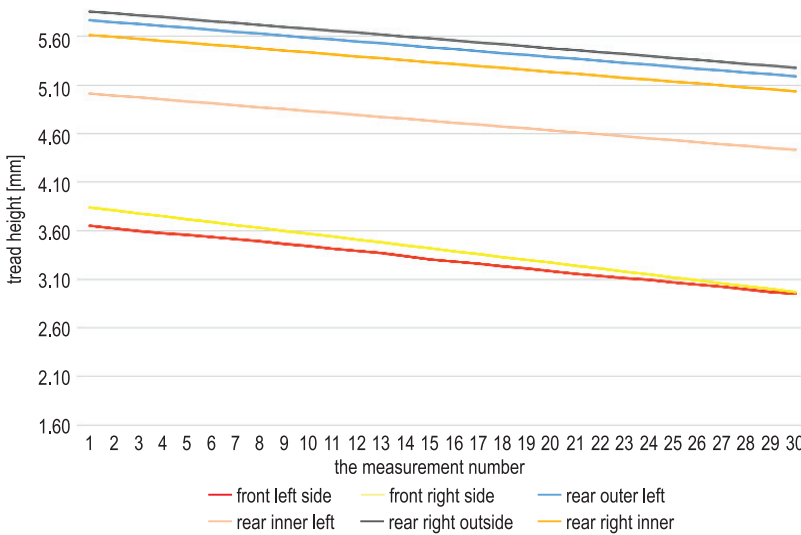
Fig. 14. Tire tread height MAN TGL 12.240

Figures 14-17 show the measurement results (mm) of the tread depth of individual tires. There were a total of 30 measurements, once a week, from August 30, 2014 to February 1, 2015 (it was each Sunday after the end of work). The starting point of the charts was set at 1.6 mm as the minimum tread height allowed for traffic. The exception is the chart showing the tread height of the MAN FH2000 trailer tires, due to the low tread height.

The research shows that in trucks used for driving lessons, tire wear is not uniform over their entire width. Tires wear out as follows:

1. With the front axles, the tires wear out in the shape of a trapezium – internal and external parts more than the middle. The effect on this way of wear is probably due to driving on the manoeuvring square, where the maximum turns are performed at a standstill almost every time during parking manoeuvres.
2. With the rear axles, the outer part of the right-hand outer tire is the most worn. This kind of wear is also caused by driving on the manoeuvring square (e.g. driving on a curve).

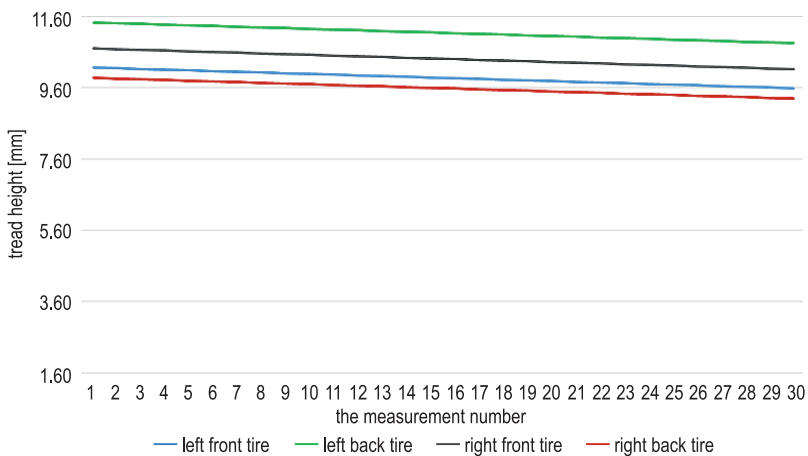
Fig. 15. Tire tread height of the car trailer MAN TGL 12.240

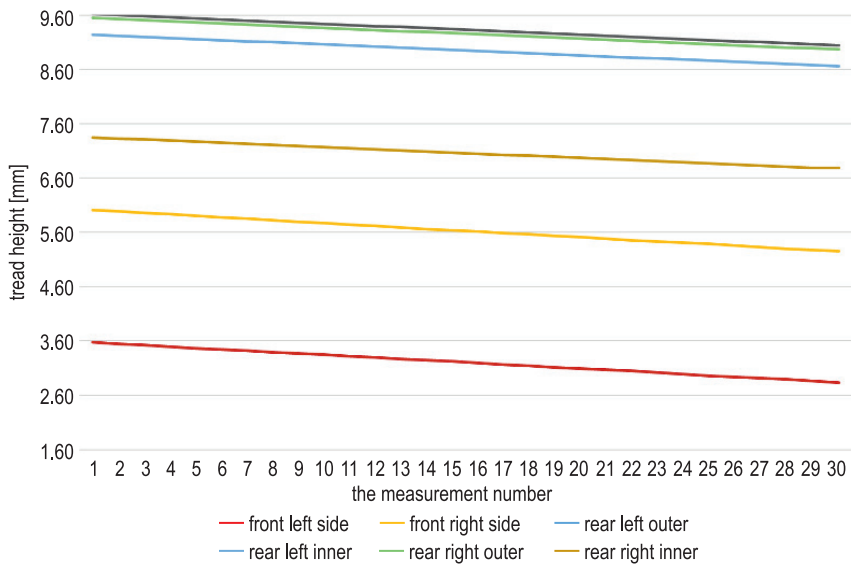
Fig. 16. Tire tread height MAN FH2000

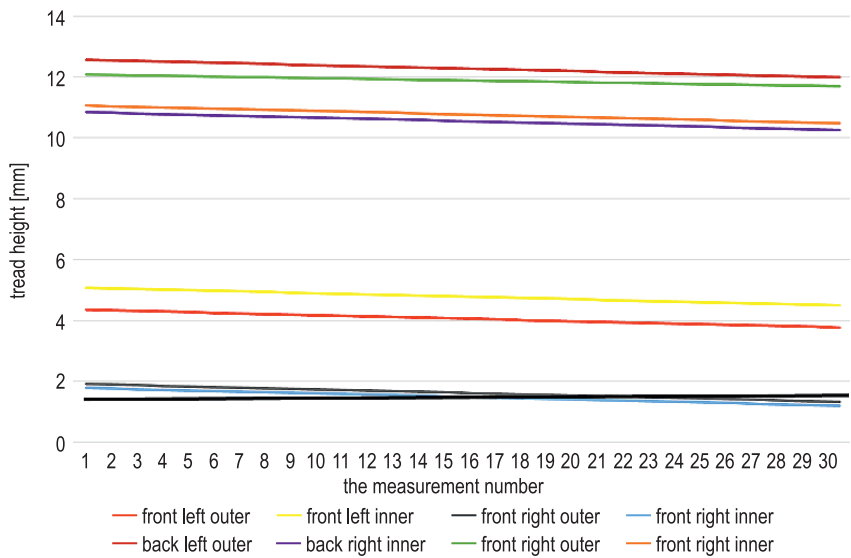
Fig. 17. Tire tread height of the car trailer MAN FH2000

5. It is advisable to replace the front right tires, both inside and outside, with the MAN FH2000 car trailer, due to the tread height being too low. It was done immediately after the measurements.
