Janusz Hochleitner

Instytut Historii i Stosunków Międzynarodowych
Uniwersytet Warmińsko-Mazurski w Olsztynie

RESTORATION OF THE MONUMENTAL SCULPTURE OF MADONNA IN THE CASTLE OF THE TEUTONIC ORDER IN MALBORK (MARIENBURG)

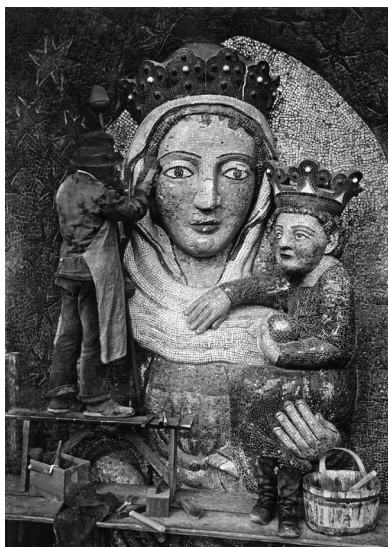
Ryc. 1. Cleaning of the mosaics on the statue of Madonna in 1903
– “Marienburg Baujahr“ 1903

The object survived until the end of WWII without major damage. Nonetheless, missing mosaic pieces had to be replaced across centuries, and also the fractured hand of the Virgin Mary had to be replaced at the start of the 20th century (Ryc. 1). The results of the most recent conservation works could have been seen as late as in January 1945.
